DEPARTMENT OF TRANSPORTATION

Quality Assurance and Source Inspection

Contract #: 04-0120F4Cty: SF/ALA Rte: 80 PM: 13.2/13.9File #: 1.28**WELDING INSPECTION REPORT****Resident Engineer:** Casey, William**Address:** 333 Burma Road**City:** Oakland, CA 94607**Report No:** WIR-029504**Date Inspected:** 02-May-2013**Project Name:** SAS Superstructure**OSM Arrival Time:** 700**Prime Contractor:** American Bridge/Fluor Enterprises, a JV**OSM Departure Time:** 1200**Contractor:** American Bridge/Fluor Enterprises, a JV**Location:** Job Site**CWI Name:** Bernie Docena**CWI Present:** Yes No**Inspected CWI report:** Yes No N/A**Rod Oven in Use:** Yes No N/A**Electrode to specification:** Yes No N/A**Weld Procedures Followed:** Yes No N/A**Qualified Welders:** Yes No N/A**Verified Joint Fit-up:** Yes No N/A**Approved Drawings:** Yes No N/A**Approved WPS:** Yes No N/A**Delayed / Cancelled:** Yes No N/A**Bridge No:** 34-0006**Component:** SAS Tower**Summary of Items Observed:**

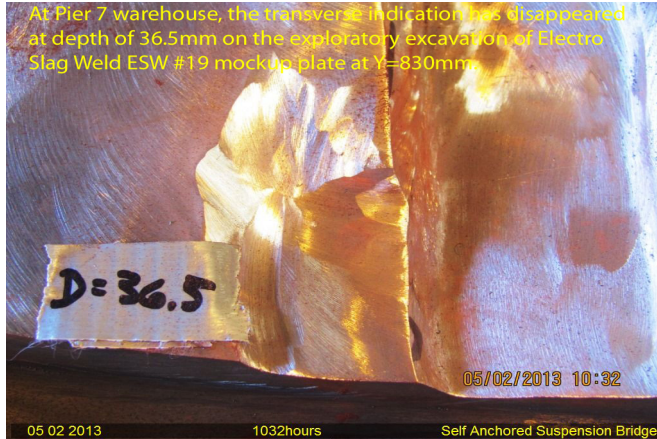
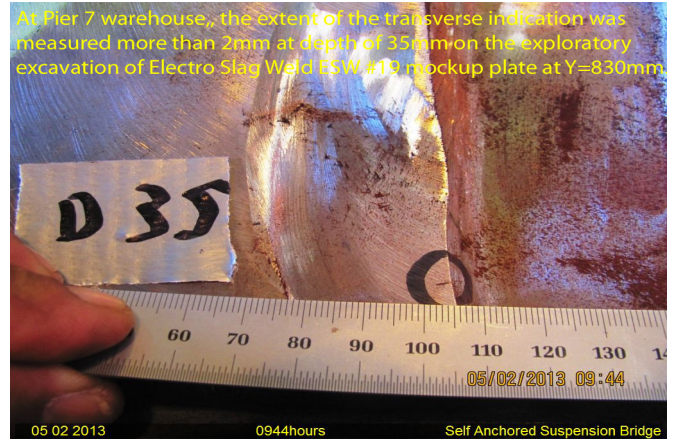
At Pier 7 warehouse, this QA together with ABF QC Bernie Docena have observed the exploratory excavation of Ultrasonic Testing (UT) detected defect on welded mock up plate ESW #19 Electro Slag Weld (ESW). ABF personnel was observed continuing to perform exploratory excavation on welded ESW at location Y=830mm where the transverse indication was found. The ABF personnel have resumed the exploratory excavation from 34mm deep with 1mm increments. The personnel were noted using only the disc grinder in every 1mm increments of excavation to the side of the transverse indication. ABF QC Bernie Docena was observed performing Magnetic Particle Testing (MT) on every depth of excavation with same 2-3mm transverse indication noted so far. This QA also performed the same test at every depth and noted same result. During the shift, the ABF personnel continued the excavation in 1mm increments using the same method of test and verification up to 36.5mm before the transverse indication had disappeared. After the disappearance of the indication, SMR Aaron Prclich was informed. The shift was completed up to this depth of excavation.

1. 34mm in depth – 2 – 3 mm transverse indication noted.
2. 35mm in depth – 3mm transverse indication noted.
3. 36.5mm in depth – no significant indication noted. Transverse indication has disappeared.
